Repair procedures

DGT 2000

Overview of versions

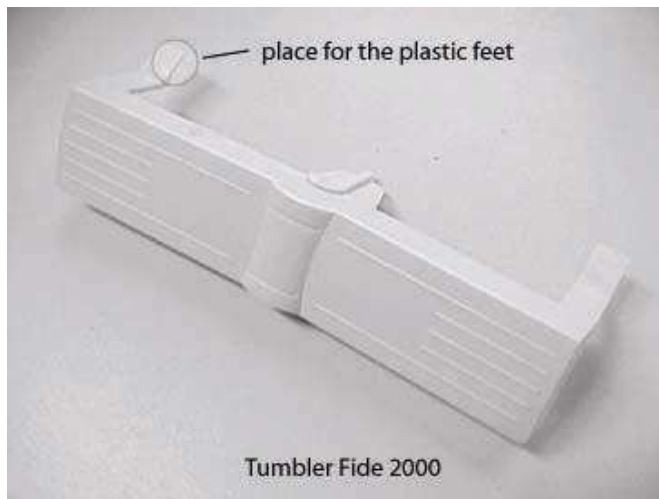
- 1) An important cause is that (one of) the small plastic parts came off the lever/Tumbler (see picture). This part is introduced around 1999. The small parts are glued to the tumbler, and if loose, will cause noise when the clock is shaken, before it is opened. Reposition it with a suitable glue (i.e. acrylic super glue)

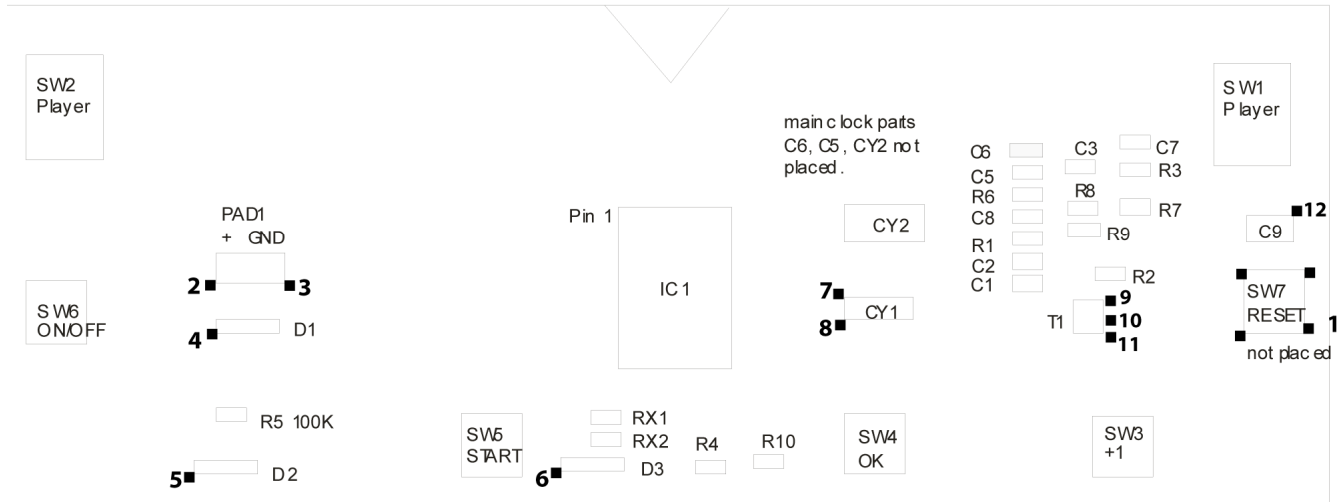
Digital Game Timer Component placement (not on scale) FIDE 2000 Measure points 2005

Measure Points (MP)

Normal operation DC Voltages on measure points:

2	:	6,45	8	:	1,94
4	:	6,45	9	:	5,89
5	:	3,08	10	:	5,25
6	:	1,56	11	:	5,89
7	:	2,89	12	:	5,93

Layout of DGT 2000 PCB and DC Voltages on measurement points

- (1) With connected batteries, the voltage between MP2 and MP3 must be 5.5 to 6.5 V DC. If not, double check batteries, battery holder and battery connector + wire.

- (2) If (1) is OK, and still not curing, check the voltage between MP1 and MP4 to be about 0.5 less than MP2/MP3 voltage. If this voltage is too low, replace D1.

- (3) If (2) is OK, and not curing, replace C9.
 - (4) If (3) is not curing, check voltage between MP1 and MP5. if OK, goto (5)
If not OK, replace C7, if not cured, also replace C3. If not cured, also replace CY1
